Project Profile:

Briar Lane

Mt. Zion Township, IL

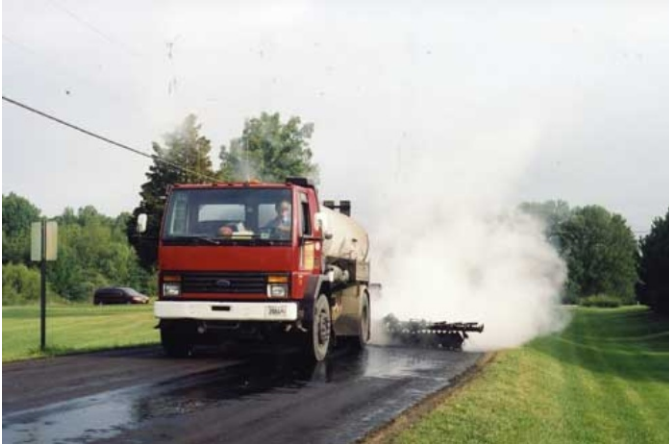
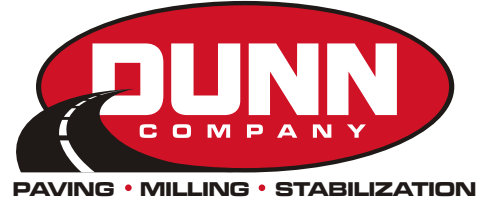
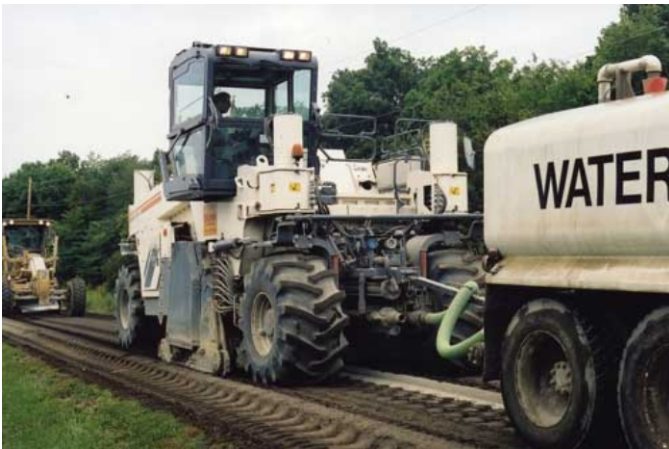
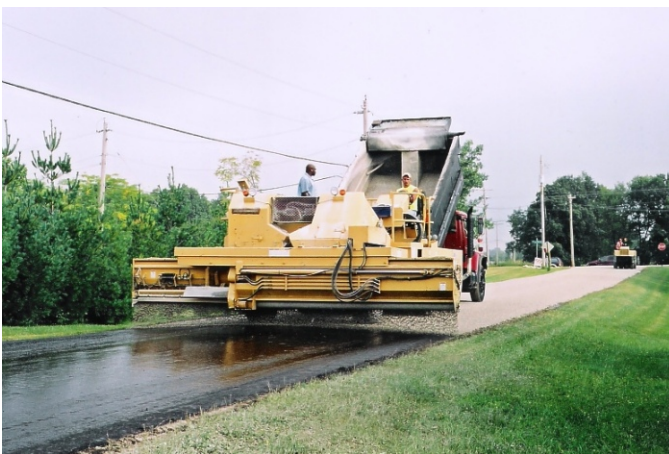
This oil and chip roadway in a rural subdivision was constructed with sub-standard materials consisting of asphalt millings, recycled base rock and waste rock. The roadway had numerous failures due to this under-designed pavement structure. Funding was not available for total reconstruction. The road was the only entry to the subdivision and needed to be kept open to traffic at all times.

A 7-inch soil cement base stabilization incorporating the existing aggregate base and oil and chip surface with the underlying clay subgrade provided the necessary strength to support the anticipated traffic.
Construction Phasing

Phase 1: Till existing roadway 6-inches deep incorporating existing base and surface material.

Phase 2: Incorporate approximately 7 percent Portland cement by weight, add sufficient water to achieve optimum moisture and mix to a depth of 7 inches and compact to optimum density.

Phase 3: Apply bituminous prime coat at one-half gallons/sy and allow to cure for 72 hours.

Phase 4: Apply A-2 bituminous surface treatment with asphalt emulsion and crushed stone seal coat aggregate.
